**INVESTIGATION OF THE SONIC FATIGUE
CHARACTERISTICS OF RANDOMLY EXCITED
ALUMINUM VISCOELASTIC PANELS
AT AMBIENT TEMPERATURES**

by B. J. Moskal

Prepared under Contract No. NAS 1-4728 by
NORTH AMERICAN AVIATION, INC.
Columbus, Ohio
for Langley Research Center

NATIONAL AERONAUTICS AND SPACE ADMINISTRATION • WASHINGTON, D. C. • APRIL 1966

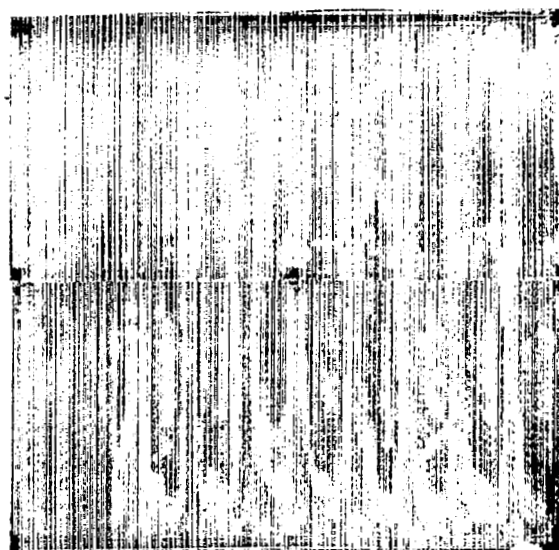
SLIGHTLY RIPPLED AL. SHEET

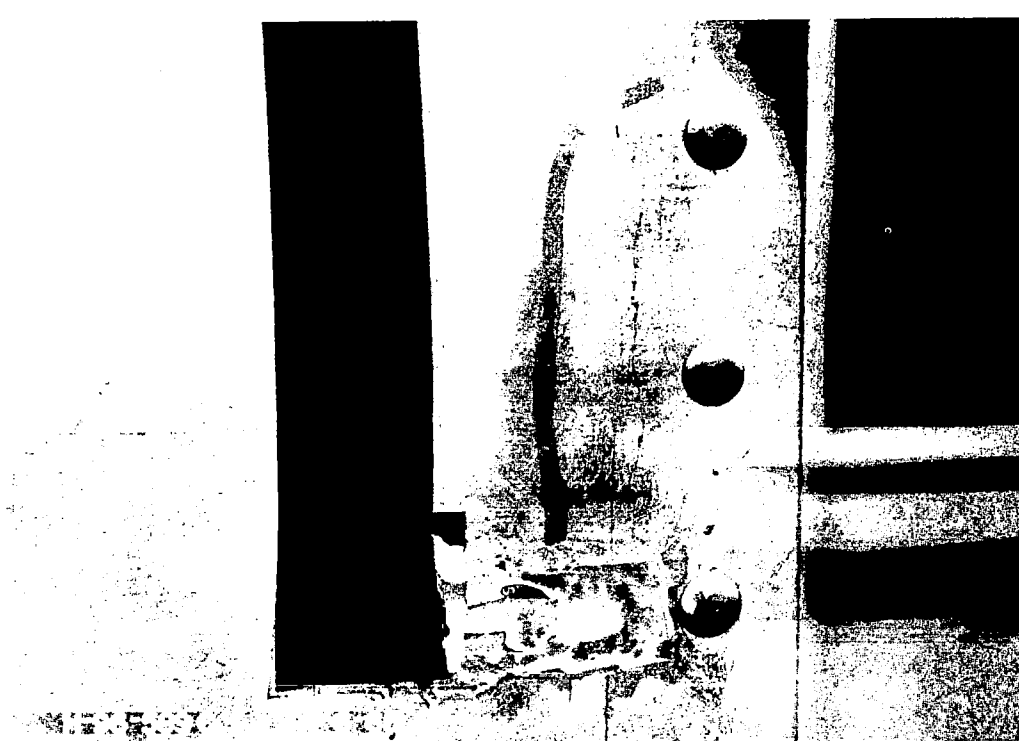
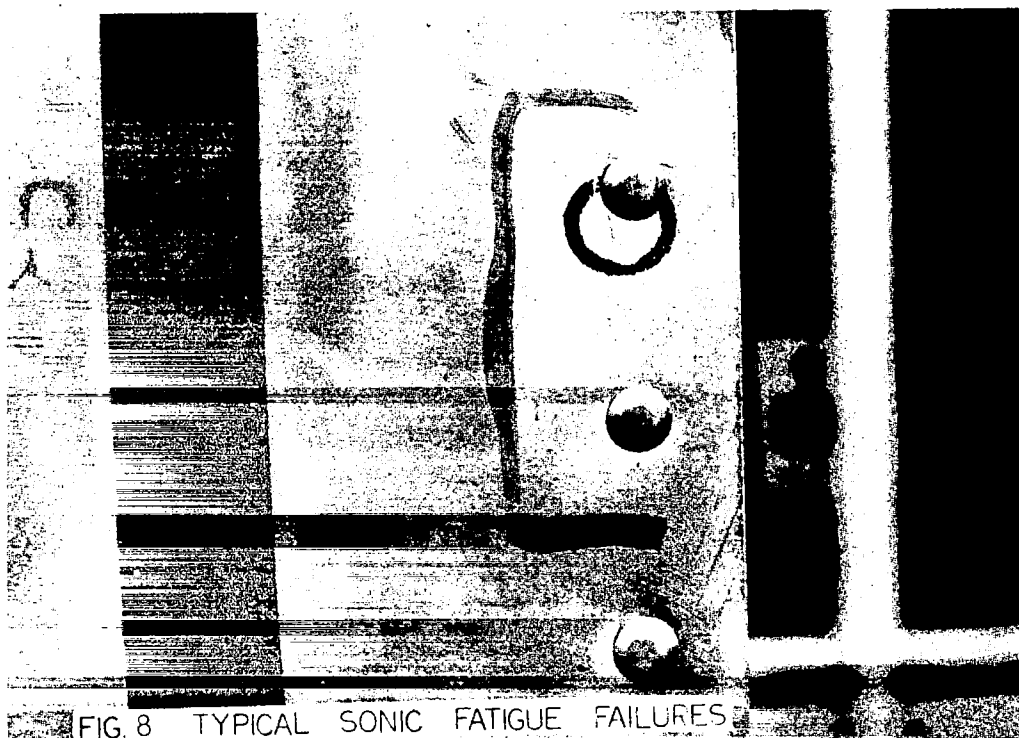
FIG. 8 TYPICAL SONIC FATIGUE FAILURES

For the aluminum control panel, the three primary frequencies were 170 cps, 242 cps, and 308 cps at a test level of 154 db as seen at strain gage position #5. As the SPL was increased, the 170 cps mode, which was identified as the fundamental frequency of the center bay area from modal mapping, increased to 185 cps and 200 cps at SPL's of 157 db and 160 db, respectively. No significant changes were noted at the other two frequencies. However, a variation of ± 10 cps was noted from the above listed frequencies at the other strain gage locations. The primary response frequency and the point of maximum stress concentration was measured at 308 cps in bay area #3. This was the area where sonic fatigue failure occurred in all panels. Failures were characterized by minute cracks propagating along the downstream flange rivet line on the back side of the panel. The majority of the failures occurred approximately 1 - 2 inches above and/or below strain gage #5. Two of the control panels exhibited failures 6 inches above the stated reference position. The cracks would generally emanate from the rivet and progress in a downward or upward direction. Several cracks had developed 1/4" to 3/8" from the rivet center line as seen in figure 8.

The character of fatigue failure of the v-e panel is similar to that of the control panel. Failure occurred in bay area #3 and 1 - 2 inches above or below gage #5. A representative panel crack is displayed in figure 8.

4. All of the fatigue failures occurred on the back side of the panel (away from the sound field) near the flange rivet line in bay area #3 (bay area #3 is downstream from the sound source). The cracks would generally emanate from the rivet and progress in a downward or upward direction. Several cracks had developed $1/4"$ to $3/8"$ from the rivet center line as seen in figure 8.
